## THERMOGRAPHIC LEAK INVESTIGATIONS

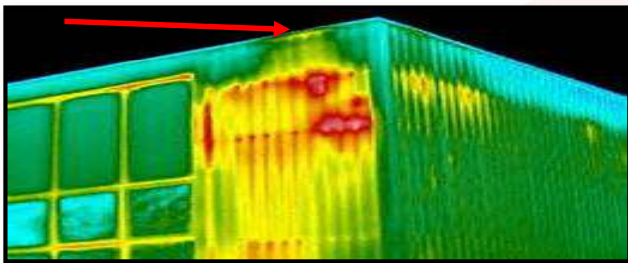
Extensive mould was found in an office building and the owners and the occupier could not locate the leak. Thermal imaging was used along with other equipment to analyse the building and find where the source of the leak was located.

This image identifies the extent of water damage and where the water was entering. The ingress of water was due to poor installation of flashings.

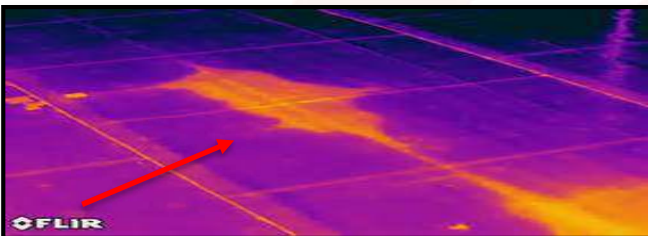
This image was taken of a balcony during a building handover inspection, initially this was highlighted by the drummy tiles. Thermal imaging highlighted the moisture trapped underneath the tiles, as a result final payments were withheld until the rectification of the defective work was completed.

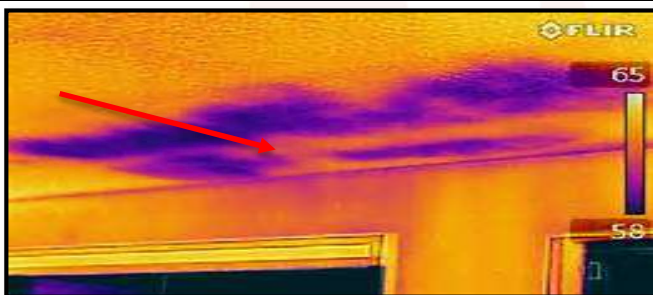
Extensive moisture was found in a ceiling during a pre-purchase inspection. The seller had painted this ceiling to disguise the water leak caused by a pipe in the unit complex.

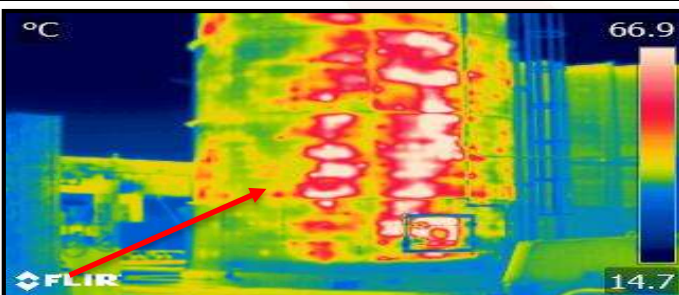
This image was taken of the exterior of a water tank. This Inspection was requested by the water utility company to verify the extent of the water that was leeching through the concrete tank because of failed internal coatings. This allowed the utility company to verify the extent of leeching and prioritise the remediation works that were required.
